## **An Altro customer guide**

Inspecting floors and walls -  
best practice

# Best practice floors and walls installation: the do's and don'ts

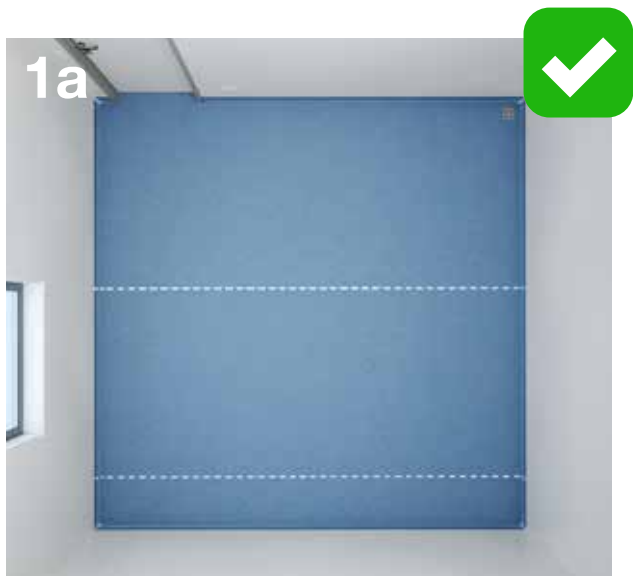
This shows the ideal layout of joints (seen from above).

**Reason why this is good**

It is aesthetically pleasing to draw attention away from the joint. It is placed away from the heaviest foot traffic.

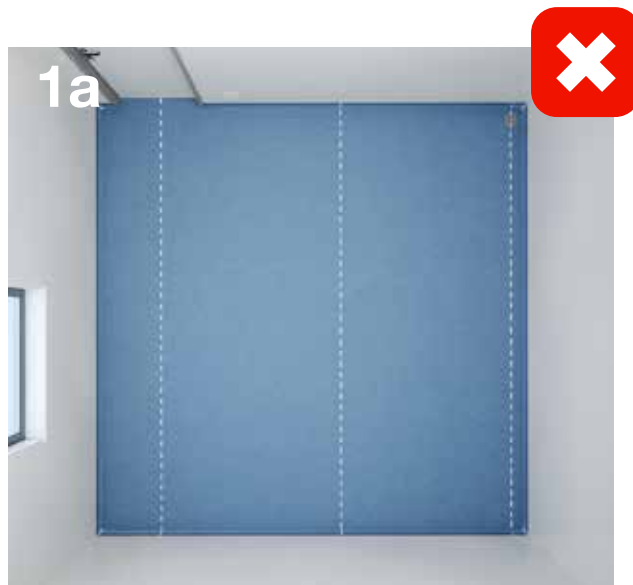
This shows the joint in the middle of the doorway (seen from above).

**Reason why this is bad**

Your eyes are drawn to the joint in the centre of the room, detracting from the aesthetics of the floor. The joint is exactly where most foot traffic goes, placing unnecessary pressure on the join.

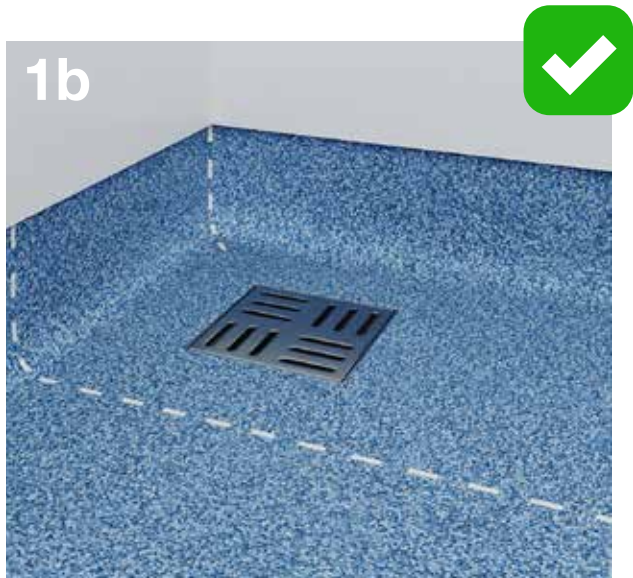
This shows the joint placed well away from the drain.

**Reason why this is good**

This provides a stronger weld, making it a more durable solution. The drain and floor are both secured, with no access point for water, bacteria and bugs.

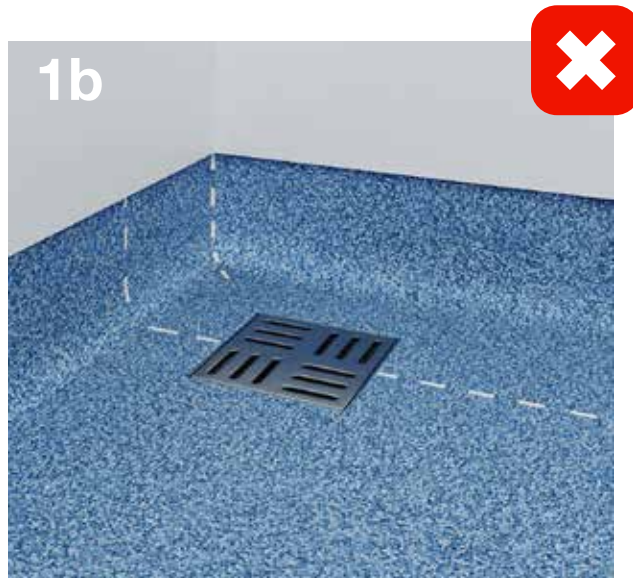
This shows the joint running across the drain.

**Reason why this is bad**

The drain and floor are not secured and the gap means there is potential for water, bacteria and bugs to get between the subfloor and flooring.

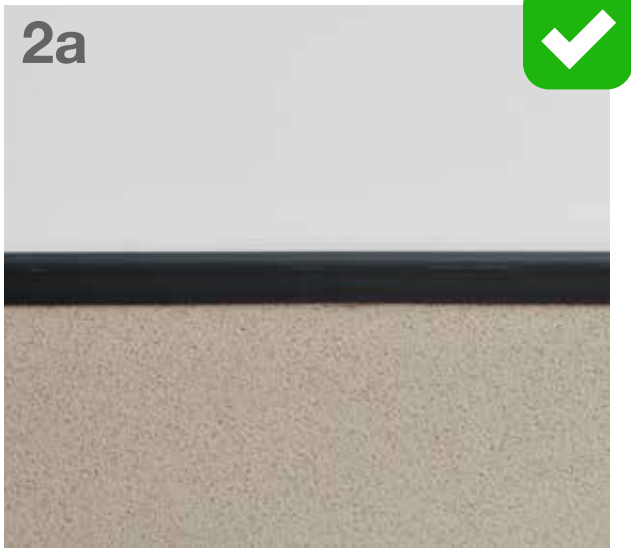
This shows a straight, level cap.

### Reason why this is good

A straight, level cap looks good, plus there are no gaps for water or dirt ingress.

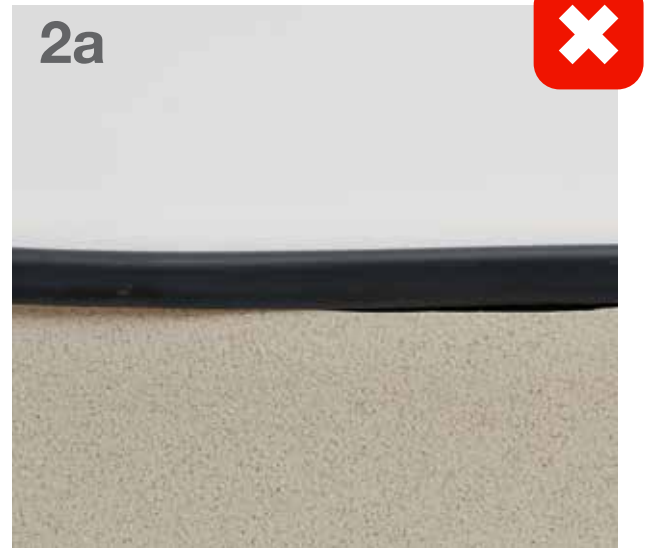
This shows an uneven cap.

### Reason why this is bad

Not only is this not aesthetically pleasing but, because there are gaps, there is potential for water and dirt ingress, leading to system failure.

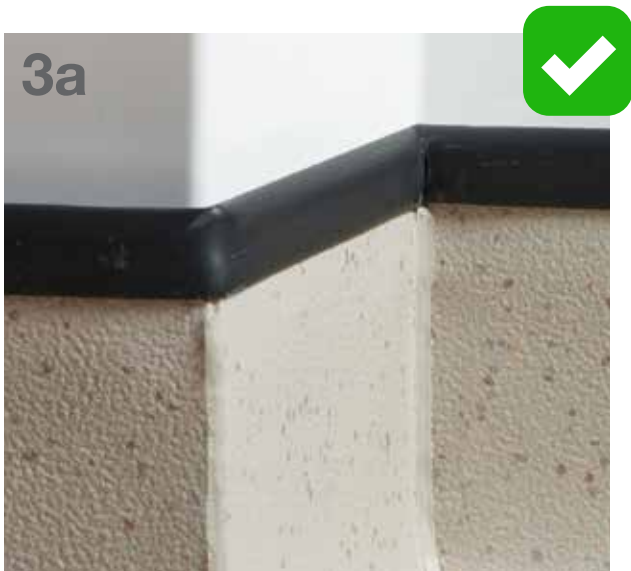
This shows best practice capping for fitting of internal and external corners.

### Reason why this is good

**Internal corner:** by cutting the capping and pushing it into the corner, it creates a better seal, making moisture ingress less likely. It also looks better.

**External corner:** by taking a piece of the capping out and wrapping it around the corner, it creates a continual capping seal, with no gaps. This is less prone to damage and is aesthetically pleasing.

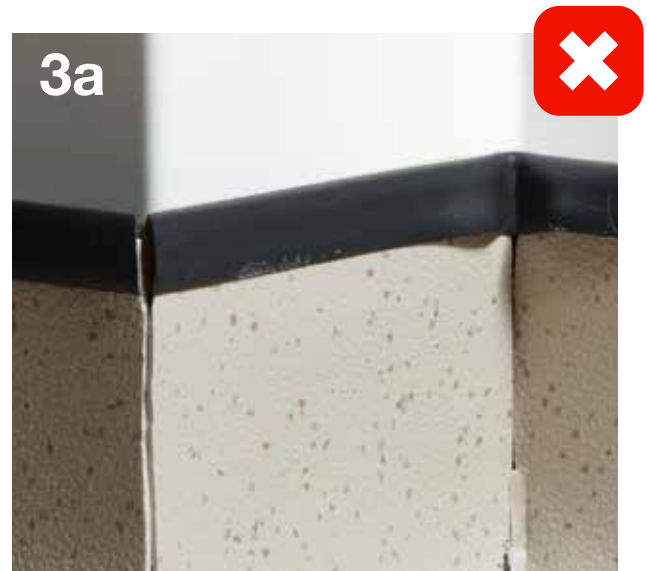
This shows poorly-fitted capping that has been mitred on the internal and external corners.

### Reason why this is bad

**Internal corner:** the corners have been mitred, and gaps in the capping can be seen, which will allow moisture ingress. The overall look is poor.

**External corner:** the capping will not be secure and water, bugs and bacteria could get into the gaps. It could also be prone to damage from passing foot and wheeled traffic.

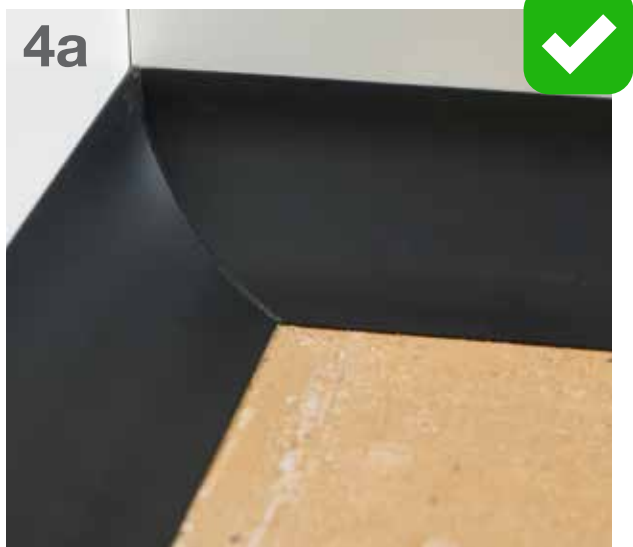
This show a best practice internal corner.

### Reason why this is good

The correctly fitted cove former gives the flooring greater support in the corners. The back section of the right hand piece has been trimmed off so that it firmly overlaps the left piece, leaving no void behind.

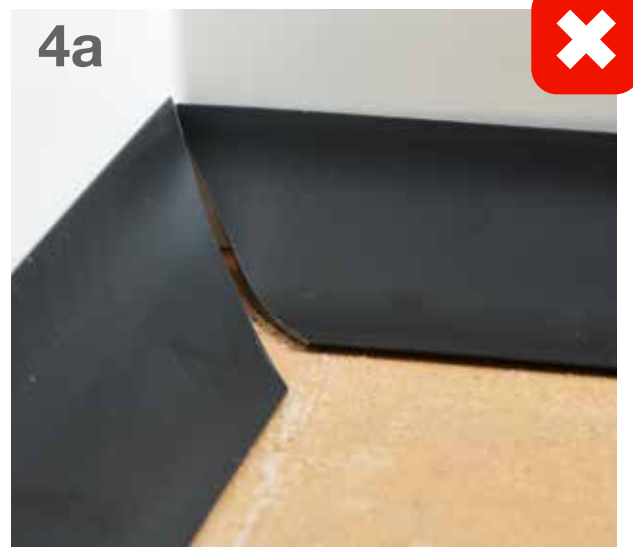
This show a badly cut and poorly fitted internal corner.

### Reason why this is bad

Where there is a gap, the cove former offers no support to the flooring, making it susceptible to damage.

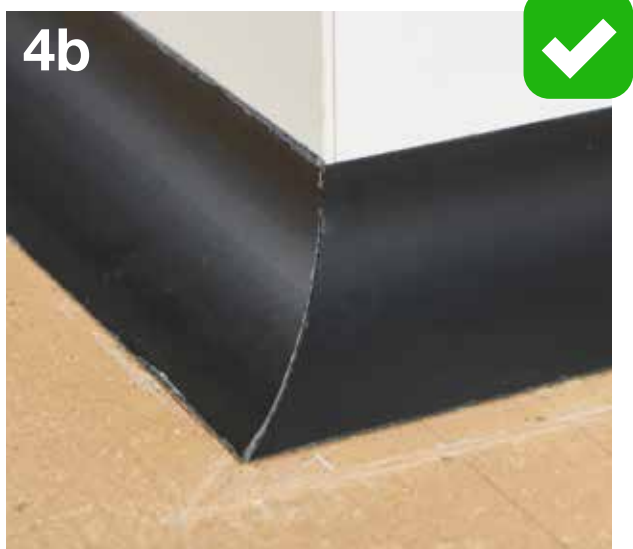
This shows a neat mitre with the cove former cut and fitted at the correct angle.

### Reason why this is good

Neatly cut and fitted with no gaps, the flooring is supported.

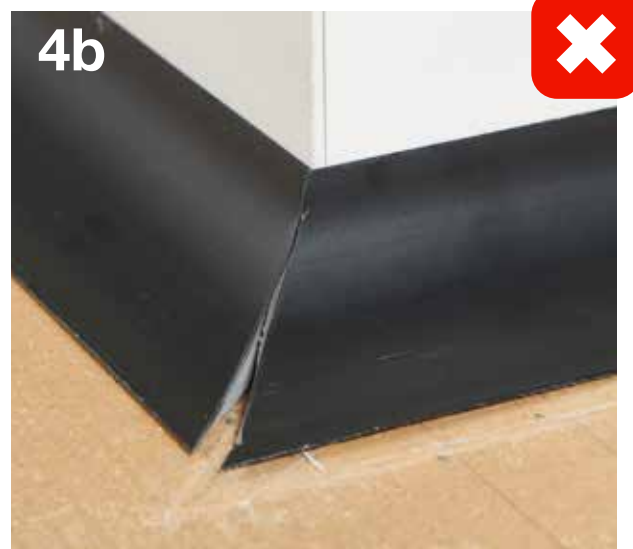
This shows a poorly cut and fitted cove former.

### Reason why this is bad

The gaps that result from the poor fit do not support the flooring that will sit on it. The floor will be susceptible to corner damage from wheeled traffic.

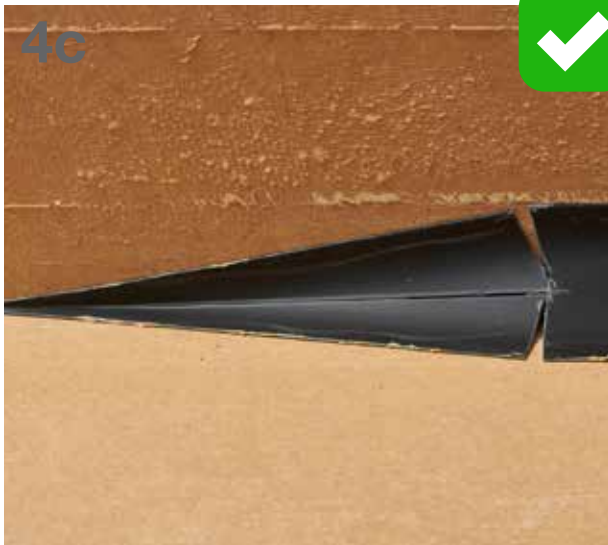
This shows a reduced cove former that will sit under the floor, next to the door frame.

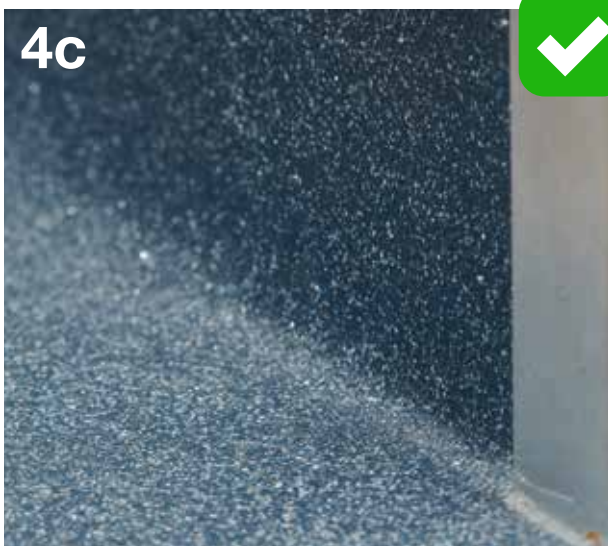
This shows the flooring installed over a reduced cove former, next to the door frame.

### Reason why this is good

This ensures there are no gaps between the floor and the door frame. It looks good and no gaps mean no open areas for water ingress or bacteria.

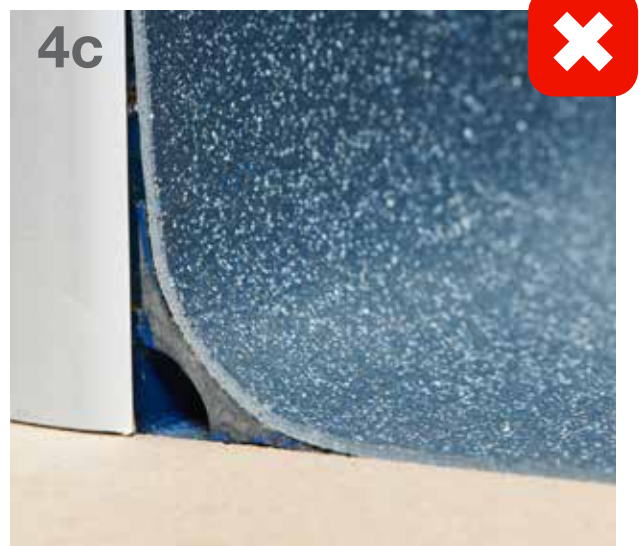
This shows the cove former leading up to the door frame, with no reduction. It sits proud of the frame.

### Reason why this is bad

Flooring that sits proud of a doorframe is prone to damage. The gap against the wall allows moisture and bacteria ingress.

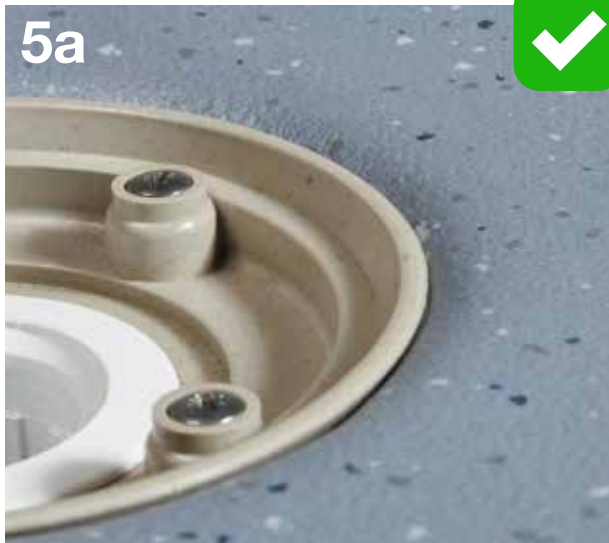
This shows the flooring folded in, with the drain fitted on top.

**Reason why this is good**

Folding the floor into a clamp drain ensures a tight, sealed fitting that prevents water and bacteria ingress.

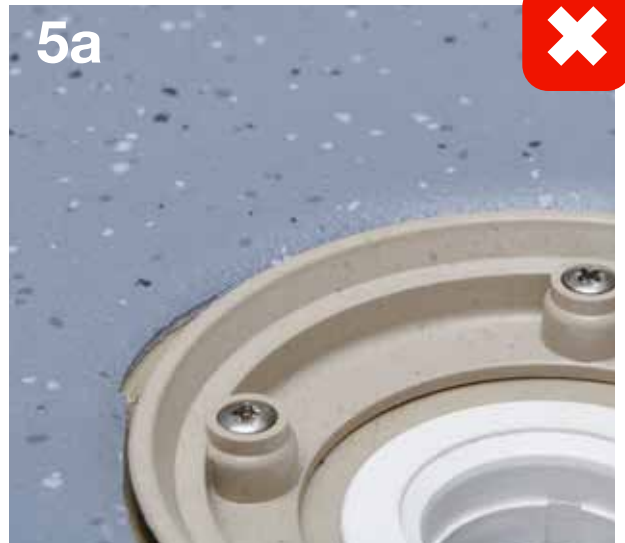
This shows the flooring cut around the top of the drain, leaving gaps.

**Reason why this is bad**

The drain is not secured and the gap between floor and drain allows water, dirt and bacteria to get between the sub-floor and flooring. This is unhygienic and can cause the floor to lift.

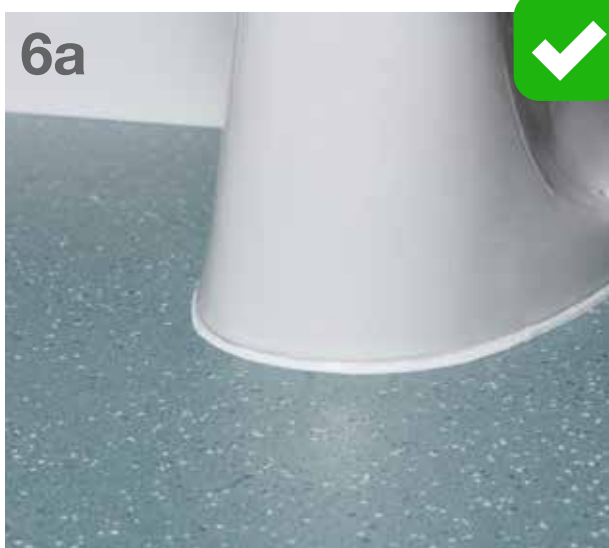
This shows a neatly cut floor, correctly sealed.

**Reason why this is good**

The sanitary ware and floor are neatly sealed with mastic, which looks good and is easy to clean. As there are no gaps, water and bacteria cannot get under the floor.

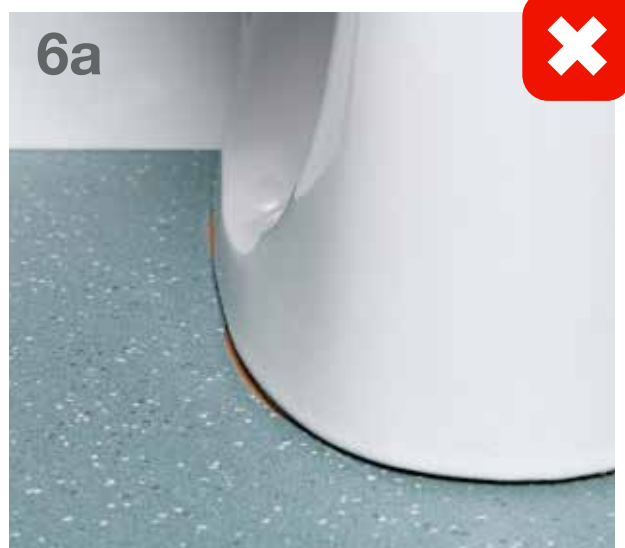
This shows a poorly cut floor with no seal between it and the toilet base.

**Reason why this is bad**

With no seal, water and bacteria will get under the flooring, cleaning will be harder, and it doesn't look pleasant.

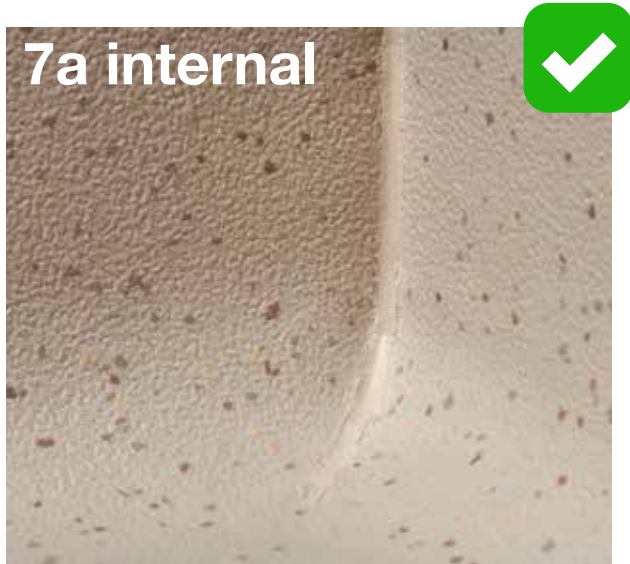
This shows a best practice hot welded internal corner, with no gaps.

### Reason why this is good

Hot welding supports the floor in the corner and ensures no gaps between the two pieces of flooring, preventing water, bug and bacteria ingress. This finish looks good too.

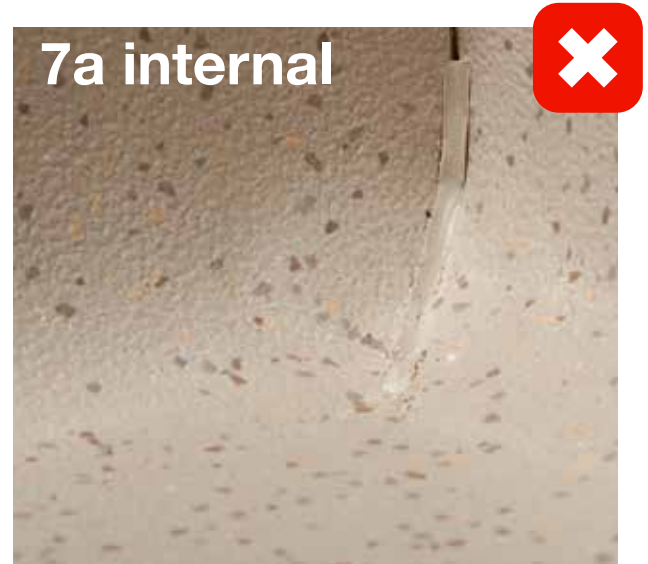
This shows an incomplete, poorly hot welded internal corner, with gaps.

### Reason why this is bad

A poor weld leaves the corner prone to damage and the gaps allow water, bug and bacteria ingress. It is not aesthetically pleasing.

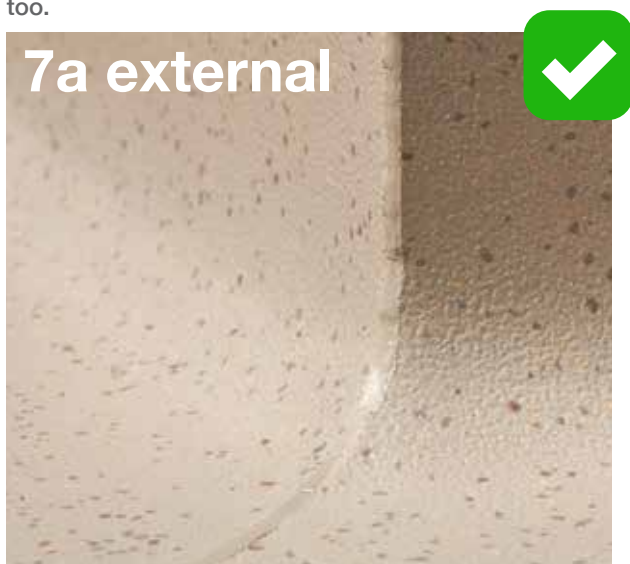
This shows a best practice hot welded external corner, with no gaps.

### Reason why this is good

Hot welding supports the floor in the corner and ensures no gaps between the two pieces of flooring, preventing water, bug and bacteria ingress. This finish looks good too.

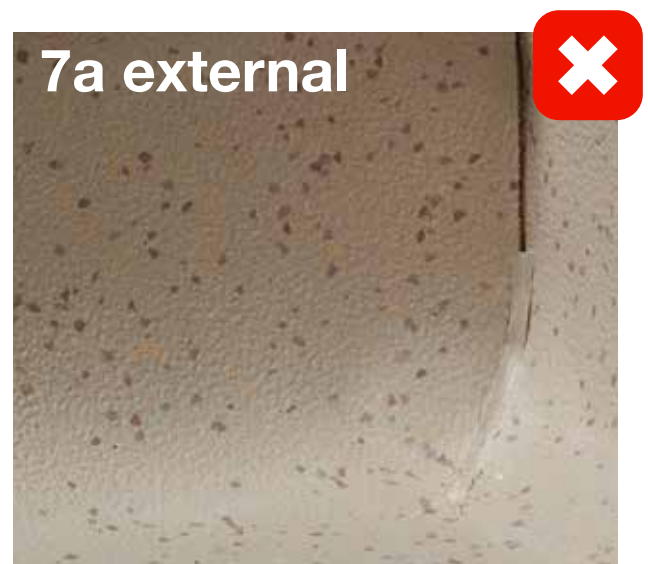
This shows an incomplete, poorly hot welded external corner, with gaps.

### Reason why this is bad

A poor weld leaves the corner prone to damage and the gaps allow water, bug and bacteria ingress. It is not aesthetically pleasing.

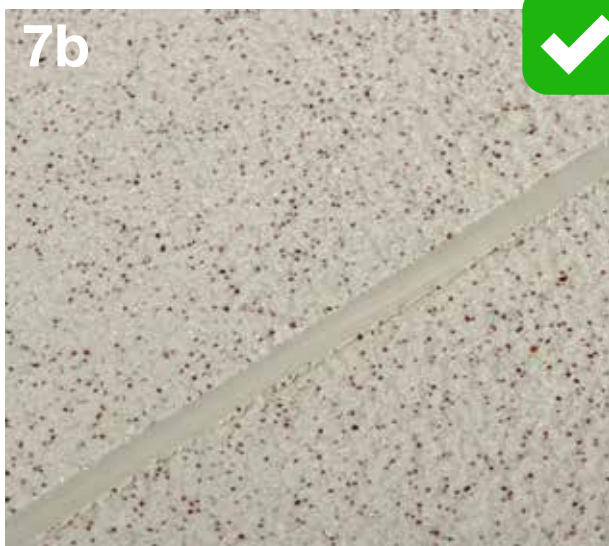
**7b**  
This shows a best practice floor weld with no gaps and trimmed correctly.

**Reason why this is good**

A neat, straight weld with no gaps either side of welded joint and trimmed correctly, ensures a secure floor with no dirt traps that is aesthetically pleasing.

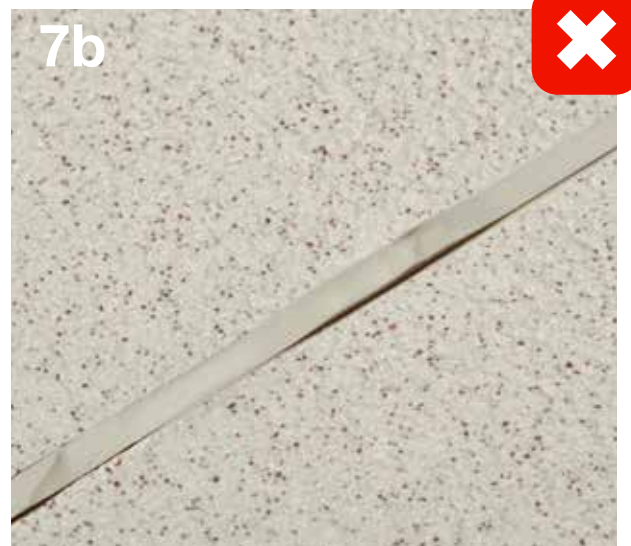
**7b**  
This shows a poor, untrimmed floor weld with gaps.

**Reason why this is bad**

There are gaps and it is unfit for purpose. A weld that hasn't been trimmed down to the surface of the floor, will create dirt traps. The look isn't good and draws the eye to the joint.

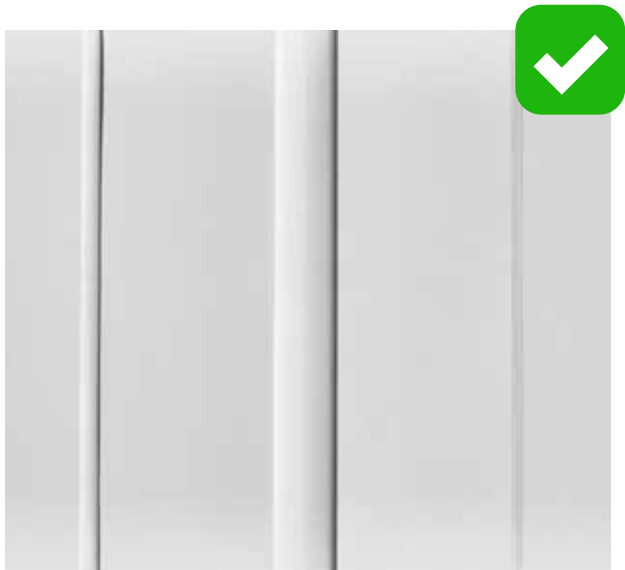
This shows the different joining methods (from left to right): Altro Flexijoint, joint trim and welded trim.

### Reason why this is good

Straight perpendicular lines are aesthetically pleasing.

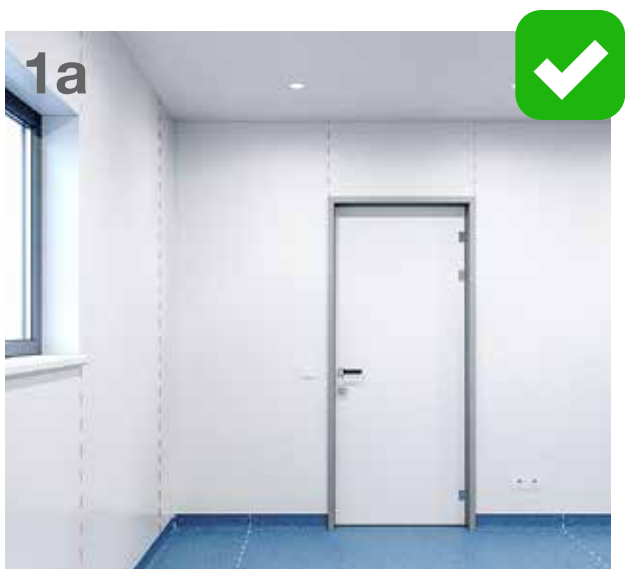
This shows well-aligned wall sheets, with the joints at a good distance from the corner and in line with the door corners.

### Reason why this is good

This room has been planned well, with good joints in the corner, doorframe and window reveal. The look is balanced and aesthetically pleasing.

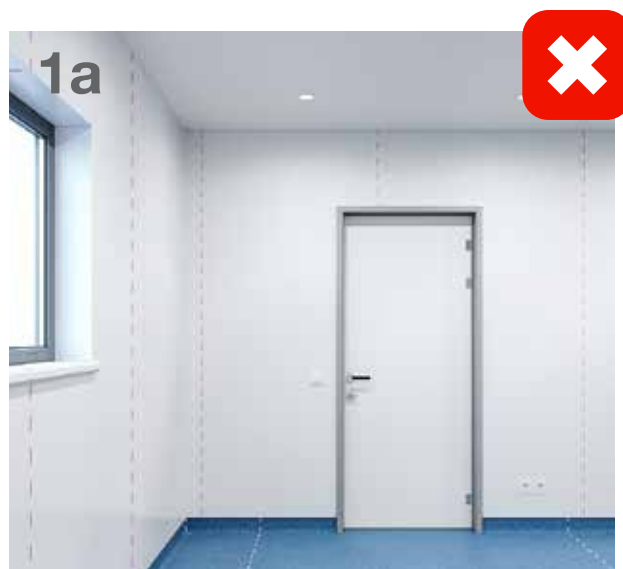
This shows the wall sheets with a joint too close to the corner and a joint in the middle of the doorway.

### Reason why this is bad

The joint in the corner of the room is closer than the recommended 300mm from a corner. Your eye is drawn to the joint above the doorway. The joints look unbalanced and aesthetically displeasing.

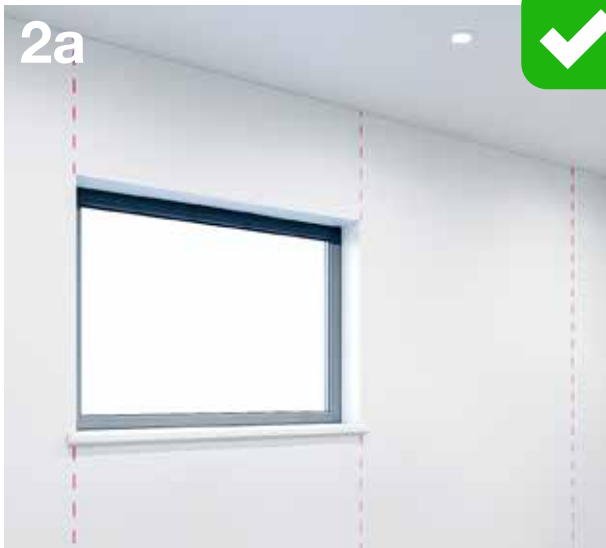
This shows the joint strips in line with the window reveals.

### Reason why this is good

The window looks neat and balanced.

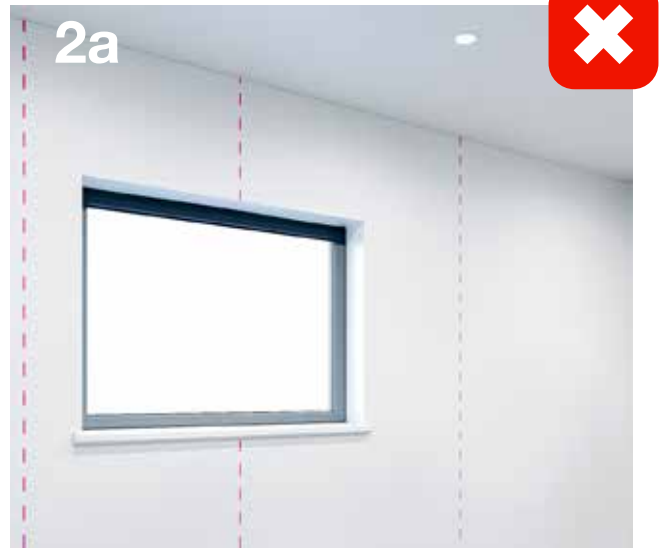
This shows a wall sheet fitted around a window with too many joints.

### Reason why this is bad

Your eye is drawn to the join in the middle of the window. The look is unbalanced and aesthetically unpleasing.

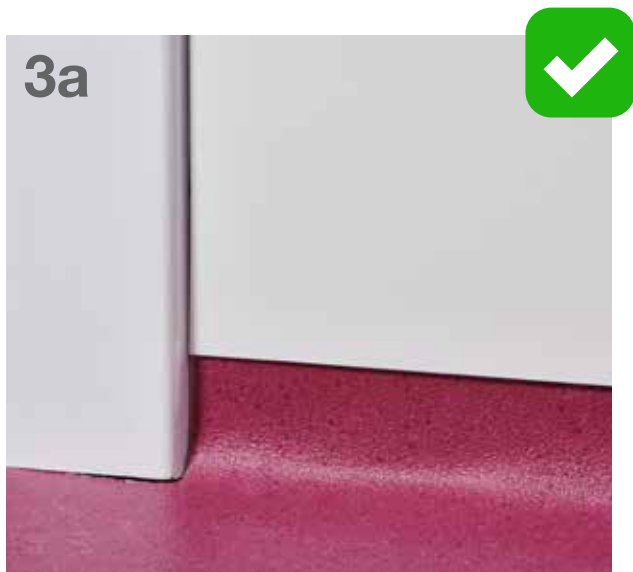
This shows a neat finish with the recommended 3mm gap, ready for sealing.

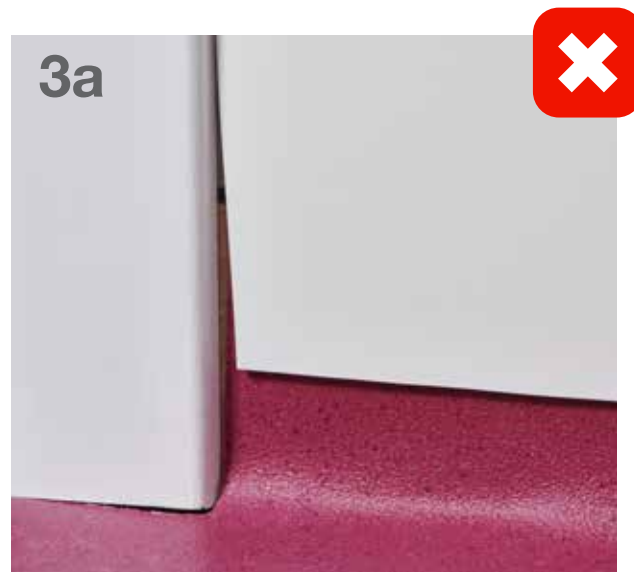
This shows a wide gap between the floor and wall sheet, and between the wall sheet and the door frame, allowing water, dirt and bugs to get behind.

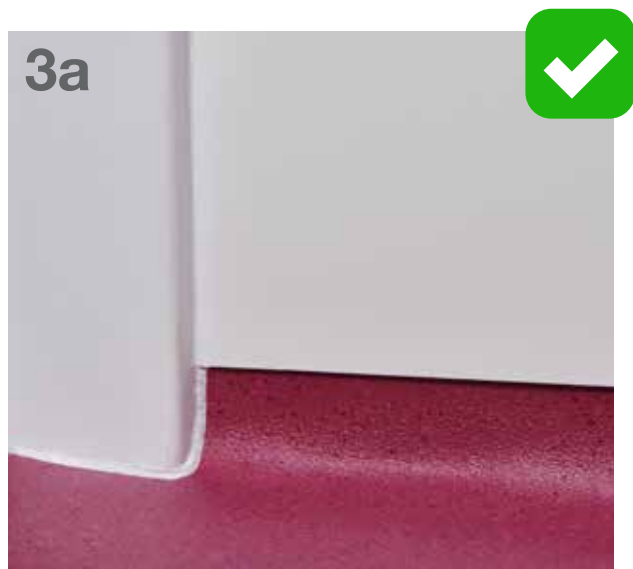
This shows a 3mm gap, neatly sealed with mastic.

#### Reason why this is good

A thin, neat edge, approximately 3mm, sealed with mastic, will prevent the ingress of dirt, bacteria and bugs. It is less likely to fail as a joint and is aesthetically pleasing.

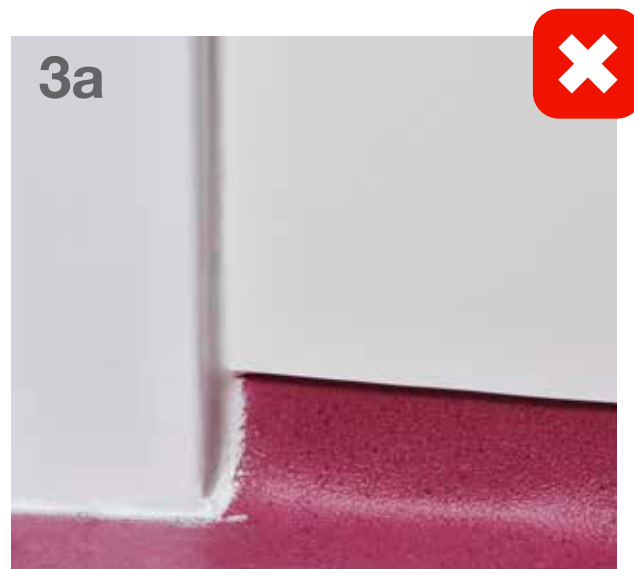
This shows a wide gap between the floor and wall sheet, and between the wall sheet and the door frame, filled with thick mastic.

#### Reason why this is bad

Thick mastic could indicate the cover up of a massive gap, that the wall sheet was not cut properly, or that the room was not planned properly. A thick layer of mastic is likely to fail, which could allow ingress of dirt, bacteria and bugs. Aesthetically, it doesn't look good.

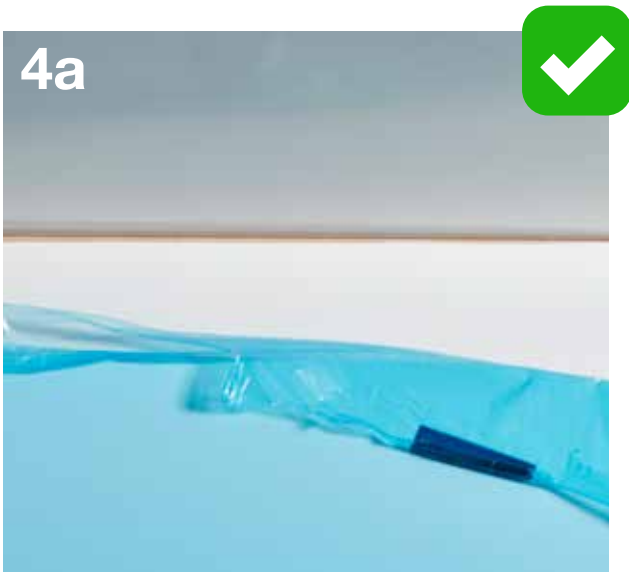
This shows Altro Whiterock joining a ceiling with a 3mm gap.

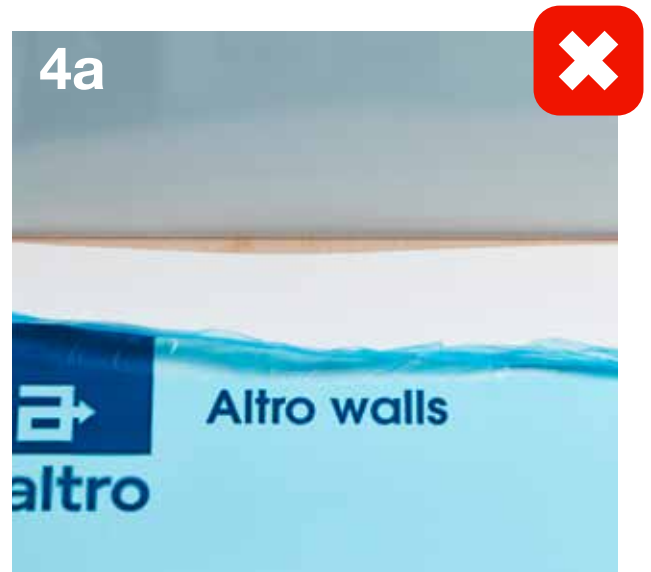
This shows a deep gap between the ceiling and wall sheet.

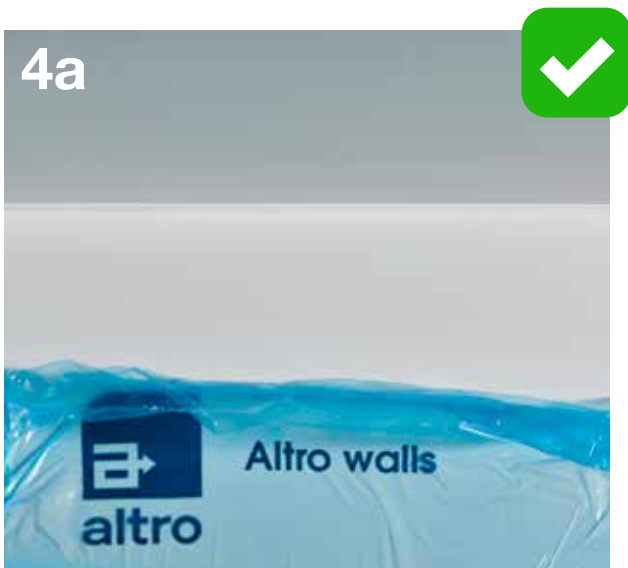
This shows a 3mm gap, neatly sealed with mastic.

A thin, neat edge, approximately 3mm, sealed with neat mastic is less likely to fail as a joint, preventing the ingress of dirt, bacteria and bugs. Aesthetically, it looks good.

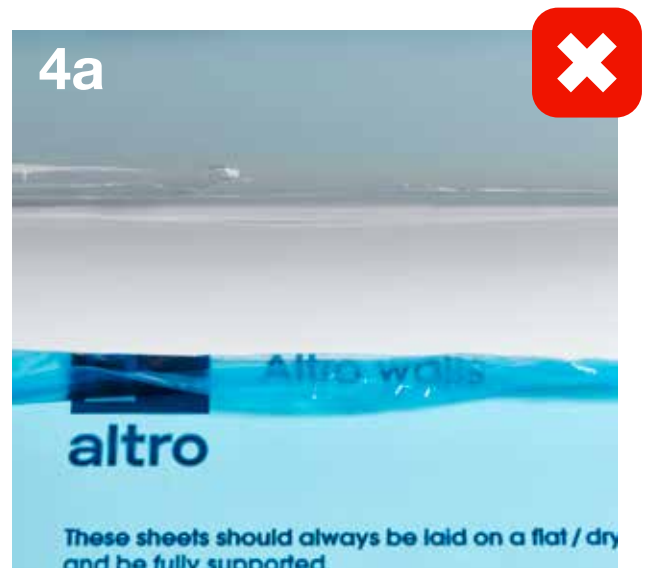
This shows the large gap filled in with thick mastic.

Thick mastic could indicate the cover up of a massive gap, potentially not cut properly, or because the room was not planned properly. It is also likely to fail, which could allow ingress of dirt, bacteria and bugs. Aesthetically, it doesn't look good.

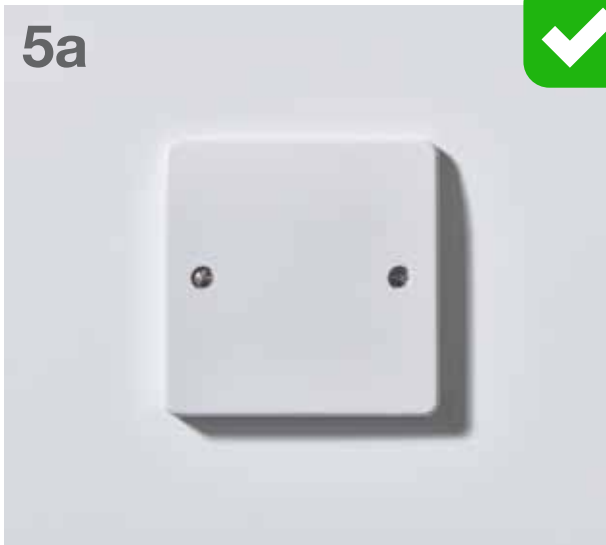
This shows the fitting overlapping the Altro Whiterock sheet.

The fitting overlapping the wall sheet is neat, tidy and aesthetically pleasing and is ideal for a non-hygienic environment.

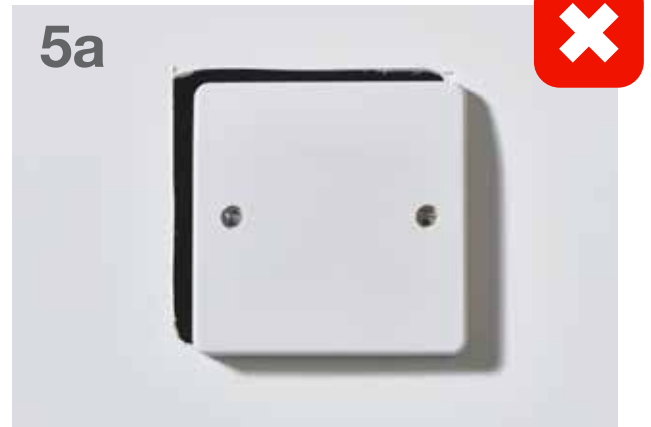
This shows a deep gap between the fitting and wall sheet.

A thick mastic, a wide gap or using additional wall sheet around a fitting shows poor planning and doesn't look good.

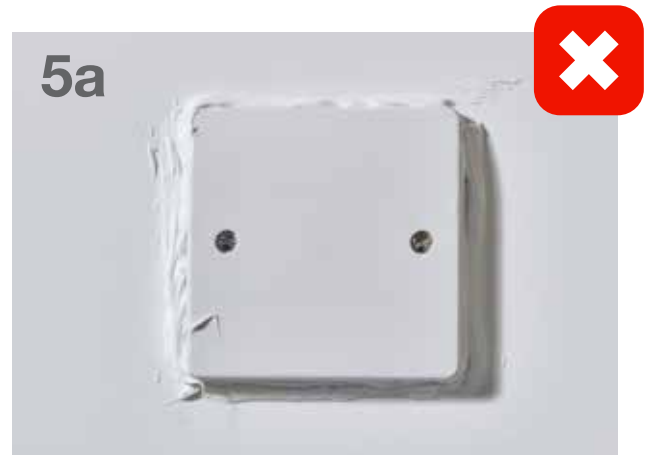
This shows the large gap filled in with thick mastic.

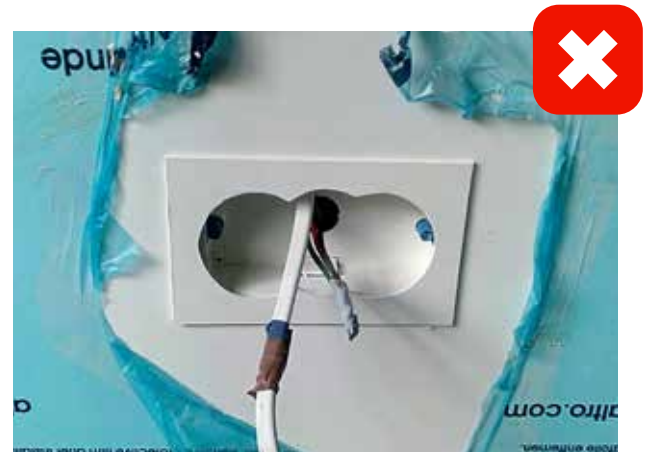
This shows a 'make-do and mend' approach. The sheet has been cut too short for the plug socket, so another piece of Altro Whiterock has been used to overlap the gap.

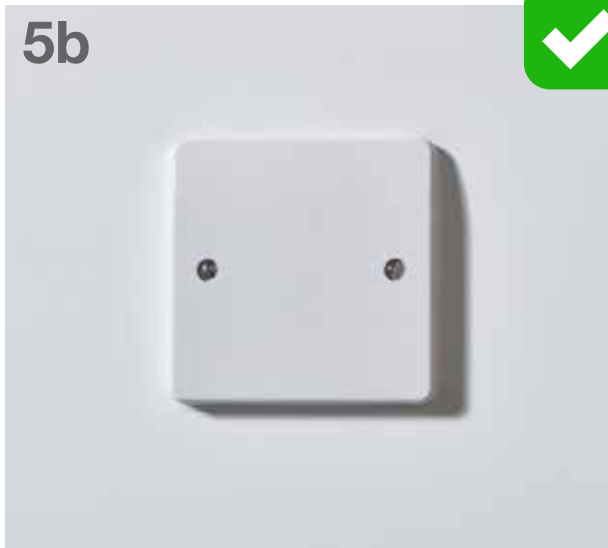
The fitting overlaps the wall sheet and is finished with a thin 3mm bead of mastic.

The fitting overlapping the wall sheet is neat, tidy and aesthetically pleasing, with a thin mastic seal (approximately 3mm) around the edge to prevent bacteria and bug ingress.

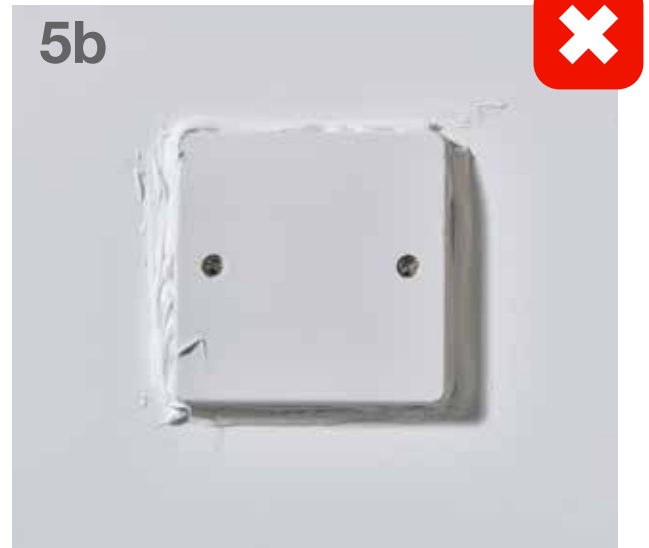
The sheet has been cut too short for the plug socket and thick mastic has been used to fill the gap.

By not having the overlapped edge, there is potential for bacteria and bug ingress. Thick mastic around a fitting is not aesthetically pleasing.

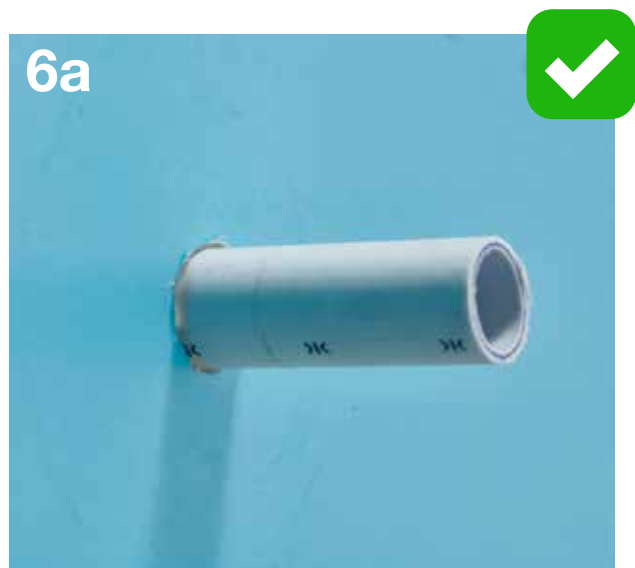
This shows a neatly cut, even sheet, with the recommended 3mm gap.

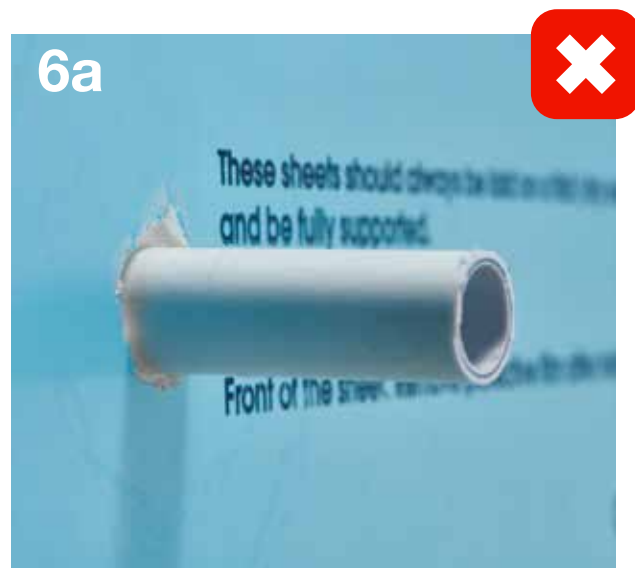
This shows the sheet, with a bad uneven cut. In parts it is wider than the recommended 3mm gap.

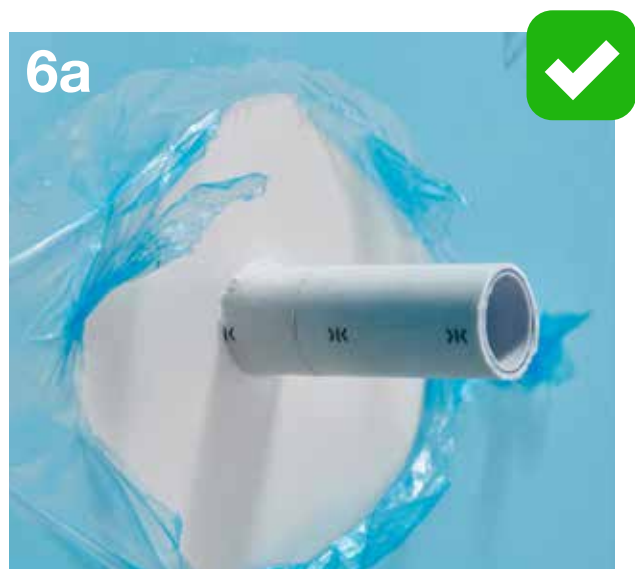
This shows pipework coming out of the wall sheet, sealed with neat mastic all the way round.

A thin, tight gap around the pipework looks good. A thin bead of mastic should be applied around any pipework or protrusions to create a neat and tidy seal (the mastic allows for movement).

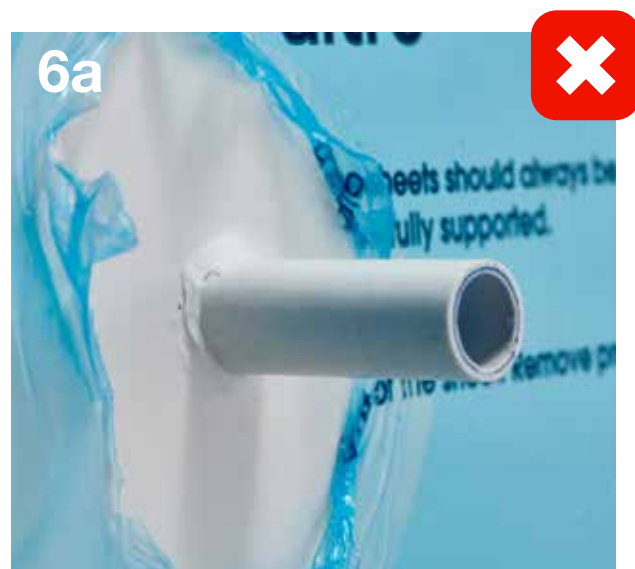
This shows an uneven, thick mastic seal with a gap on one side.

Messy mastic is not aesthetically pleasing, and any gaps allow bacteria and bugs access.

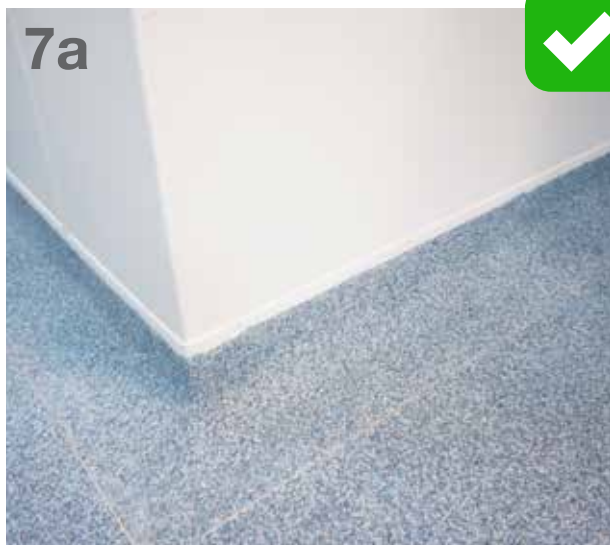
This shows best practice for an Altro Whiterock thermoformed corner.

A secure, fully-bonded, flush fitting against the wall ensures the strength of the system. In hygienic environments, it prevents potential bacteria growth.

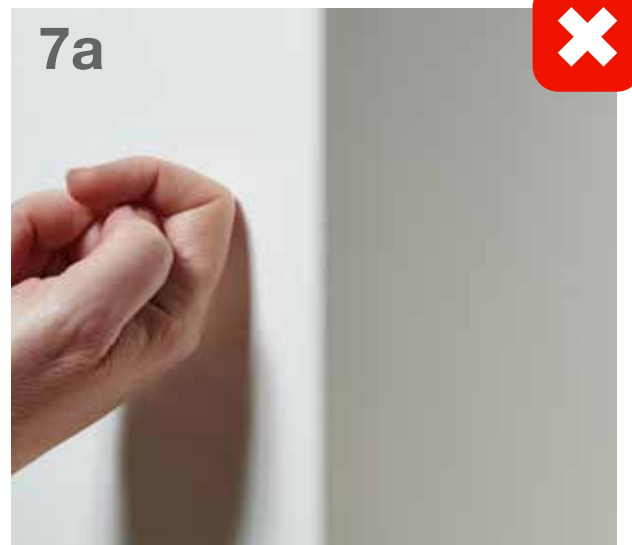
This shows someone testing the wall to check that it's fully bonded.

If the wall sheet is not fully bonded, bacteria could grow in the gaps, and the system is more vulnerable to damage.

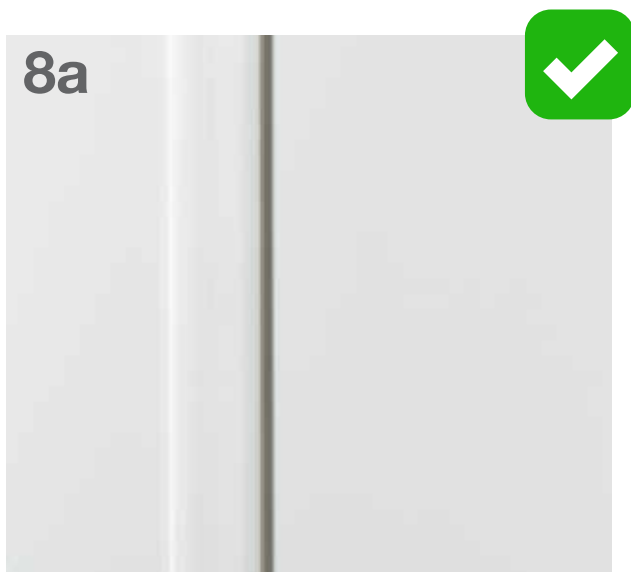
This shows an installed single-part trim.

It is generally not possible to remove a single-part trim by hand. This is particularly important in mental health spaces where a removed trim could be fashioned into a weapon or instrument of self-harm.

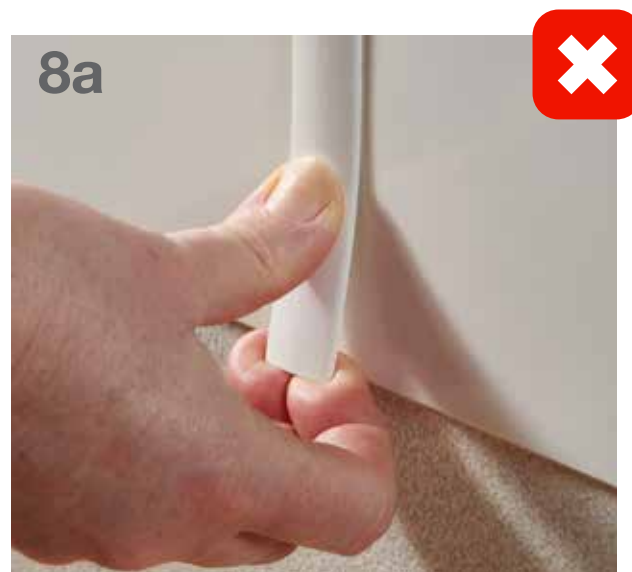
This shows a two-part trim being lifted at the base.

The two-part trim can be removed and potentially adapted into any type of weapon or instrument of self-harm.

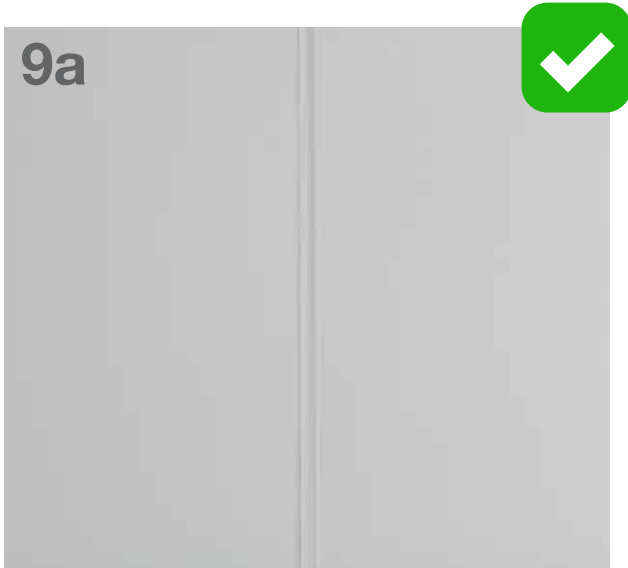
This shows a clean joint; it has a good weld with no scratches.

The joint looks neat and clean and will last longer.

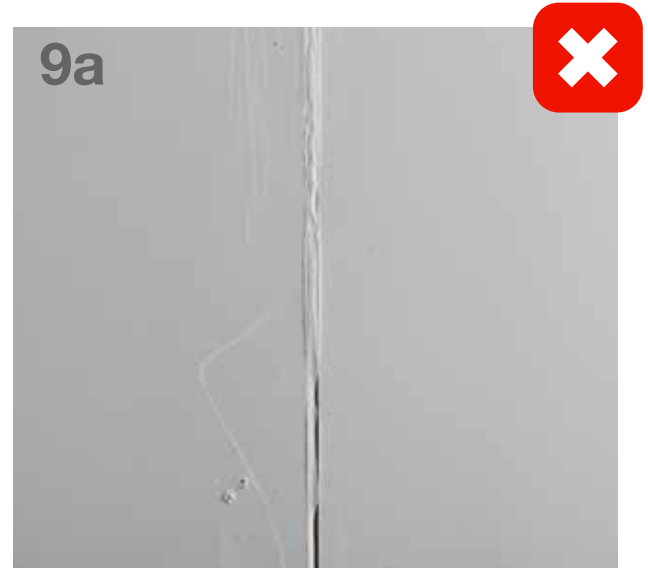
This shows a poor weld, with gaps and scratches on the wall sheet caused by tools.

It's an example of poor installation. The weld will likely fail, allowing dirt, bacteria and bugs to ingress, and it's not aesthetically pleasing.

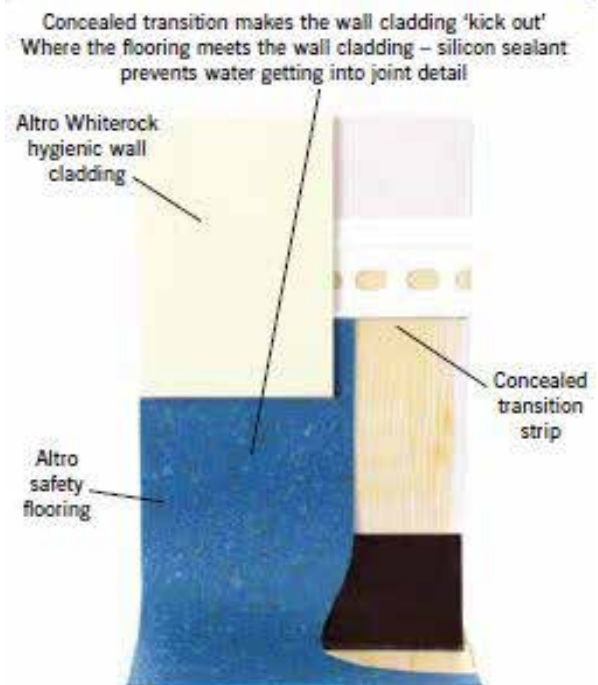
For the system to work as it should, how the flooring and wall cladding join is VITAL. The right choice is either a concealed transition strip which creates a nice curve and is often chosen for areas where looks are a factor, or a two-part transition. For anywhere that water will be present regularly, a full watertight seal should be achieved, hence the use of a concealed transition is a must!

When neither the concealed transition strip or the two-part transition strip options are used, the flooring would be laid first, then the wall cladding installed. The wall sheet would be adhered to the flooring, where it would overlap the floor by 50mm. If the flooring then needs repairing or replacing, it has to be cut away. The only way to finish the job would be to seal the two, which doesn't look good, wouldn't necessarily keep out water and other contaminants and could fail completely. – (see 10b – 'bad installation' option).

It was the case that the concealed transition would only be specified for showers and the two-part for anywhere else. Now, because the concealed transition looks so much better and guarantees an impervious system, it's by far the better choice, whatever the project.
