## **An Altro customer guide**

Inspecting floors and walls -  
best practice

# Best practice floors and walls installation: the do's and don'ts

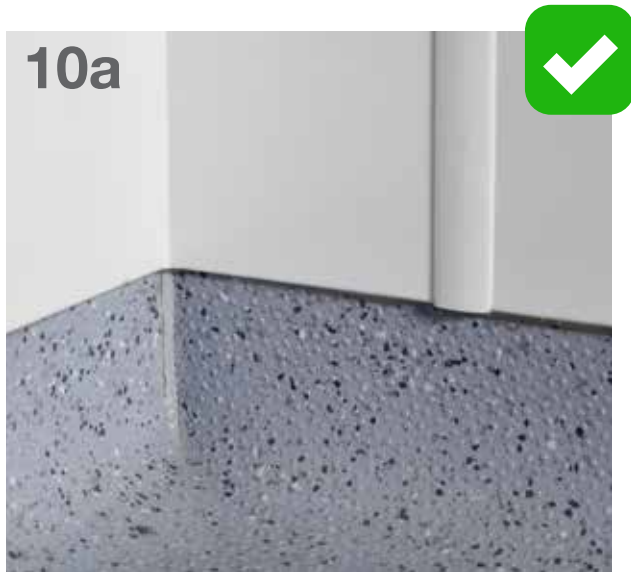
This shows an installation completed using a concealed transition strip. The wall overhangs the floor and is sealed with mastic.

Using a concealed transition means that the flooring doesn't need to be installed first. It makes the wall cladding 'kick-out' at the bottom so the flooring can go underneath and sit behind it. This means the wall sheet isn't adhered to the flooring behind, so it's easy to replace the flooring if needed. This type of transition means that any water runs down the wall and onto the flooring rather than hitting the joint. After this, the transition is silicone-sealed to avoid water bouncing back up from the floor and getting into the joint detail, creating a watertight finish.

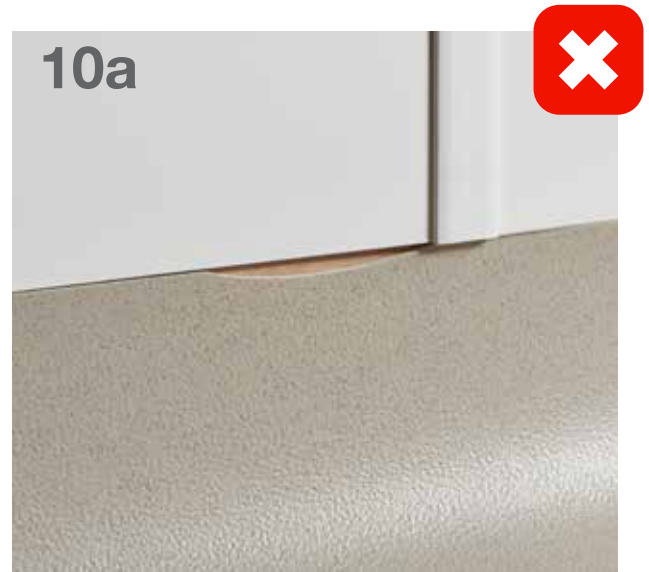
This shows flooring unevenly cut to meet the wall sheet. A concealed transition strip has not been used.

This is not a sealed system, allowing for water and bacteria ingress and a potential failure of the system.

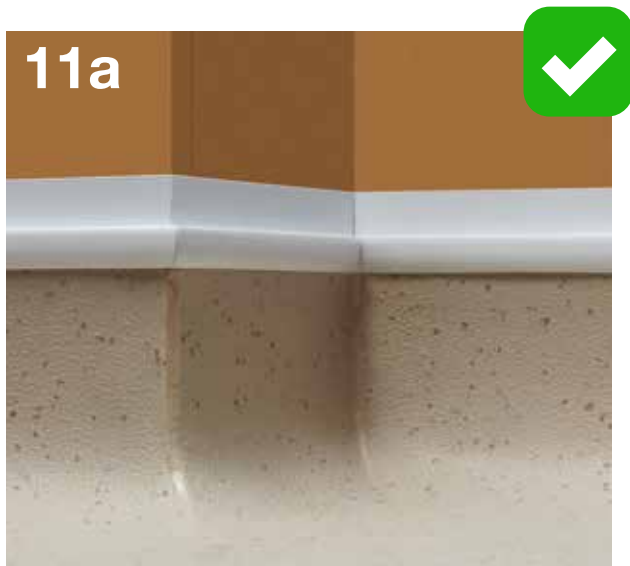
This shows neatly mitred internal and external captile corners.

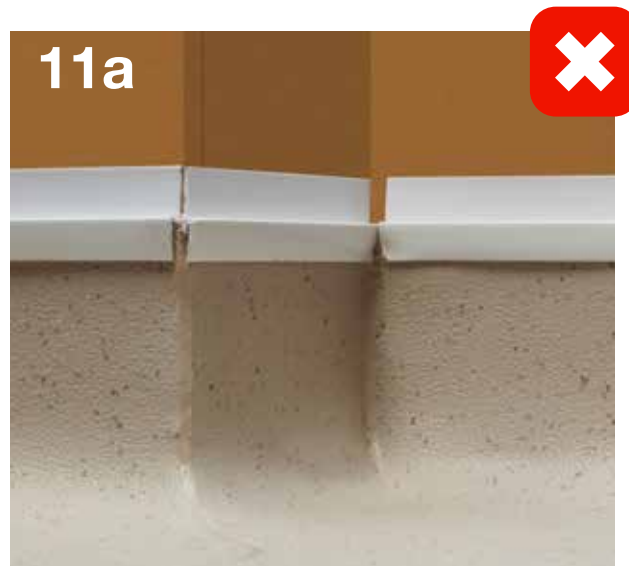
This shows poorly jointed internal and external captile corners, with visible gaps.

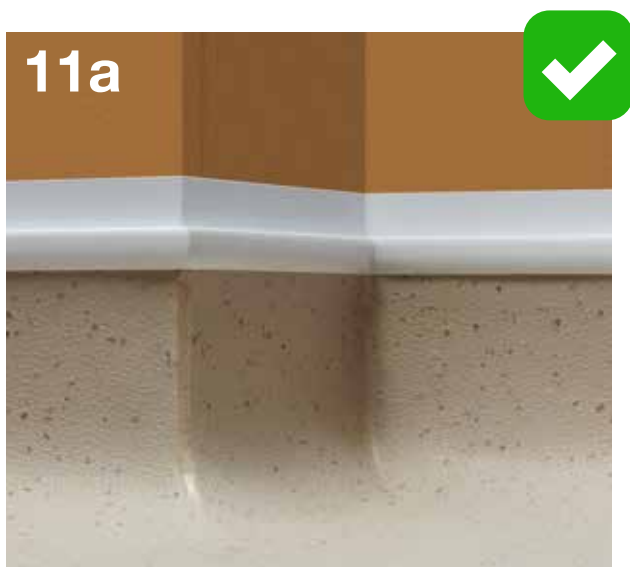
This shows both the internal and the external captile corners have been tightly mitred and finished neatly with a small amount of mastic.

In a wet environment eg. a shower room, this will allow water to drain away easily, without it getting behind the flooring material. This prevents system failure and provides a hygienic solution that is also aesthetically pleasing.

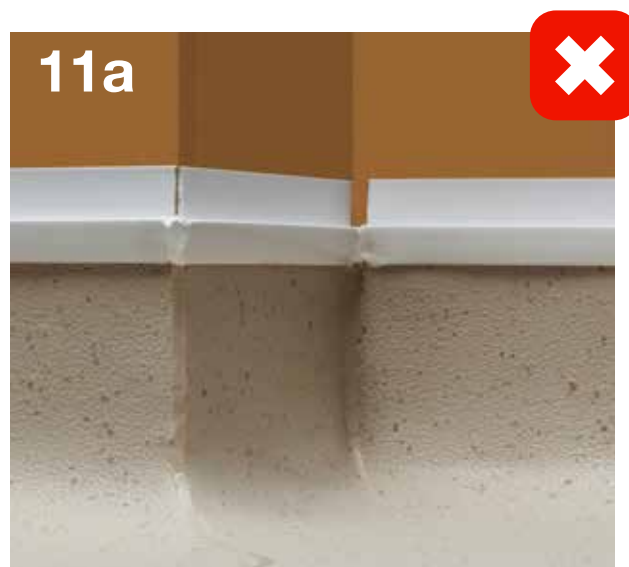
This shows poorly jointed internal and external captile corners, filled with thick mastic.

In a wet environment, water will run down the wall tiles and can find its way behind the captile strip, mastic and flooring. This could cause a system failure and is not aesthetically pleasing.

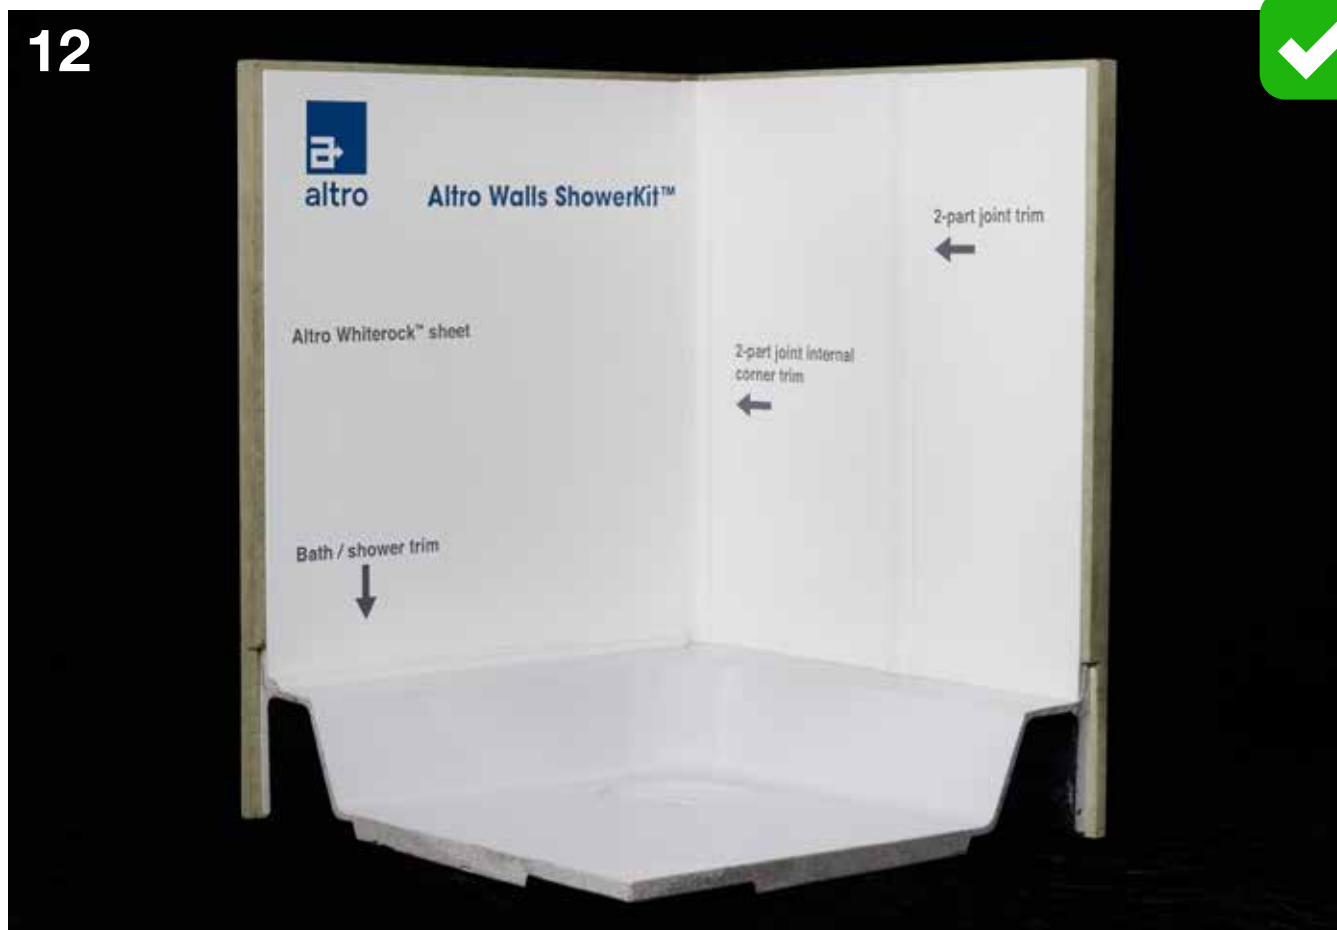
**Left-hand side:** this shows that the bath/shower trim is fitted tightly to the shower/bath top. The joints are finished with mastic to prevent water ingress.

**Right-hand side:** this shows Altro Whiterock overlapping a shower tray upstand and finished with tidy mastic to prevent water ingress.

A correctly-fitted, neat, thin mastic-sealed edge will prevent water ingress, be easier to clean and will prevent system failure.

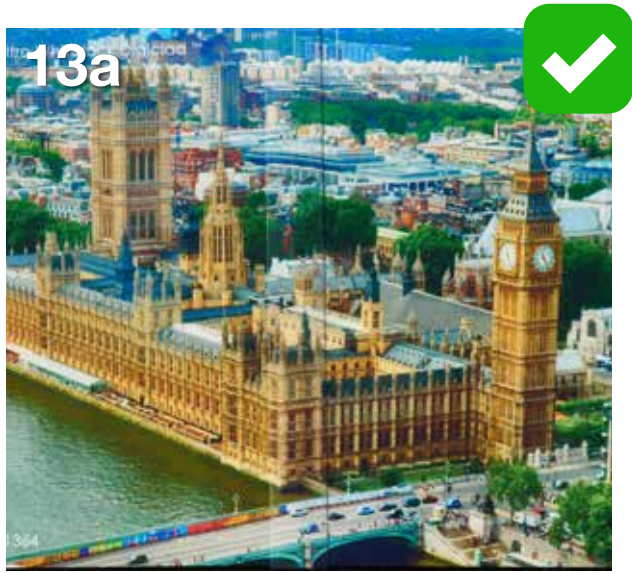
This shows two Altro Whiterock DigiClad sheets correctly lined-up, with a matching trim in place.

**Reason why this is good**  
 Aligned and aesthetically pleasing.

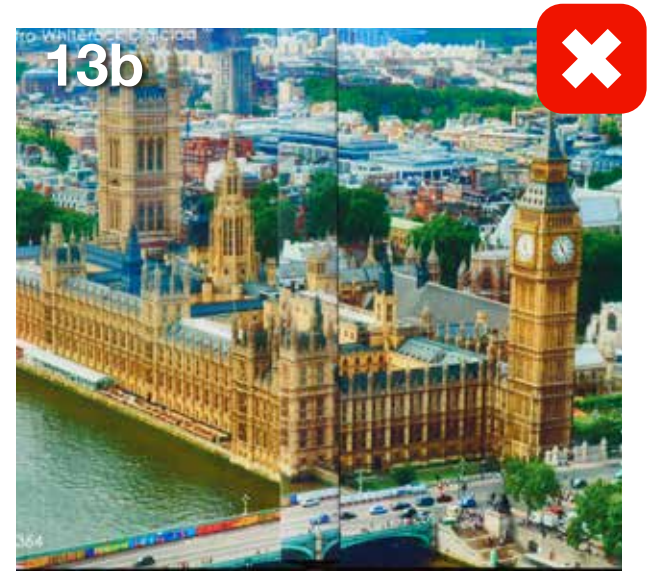
This shows two Altro Whiterock DigiClad sheets installed with a poorly aligned matching trim (take a close look at the bridge!).

**Reason why this is bad**  
 The misaligned trim spoils the overall effect of the image.
